Illinois Commerce Commission
Assessment of AmerenIP's
Reliability Report and Reliability Performance
for Calendar Year 2004

Pursuant to 83 Illinois Administrative Code 411.140

November 10, 2005

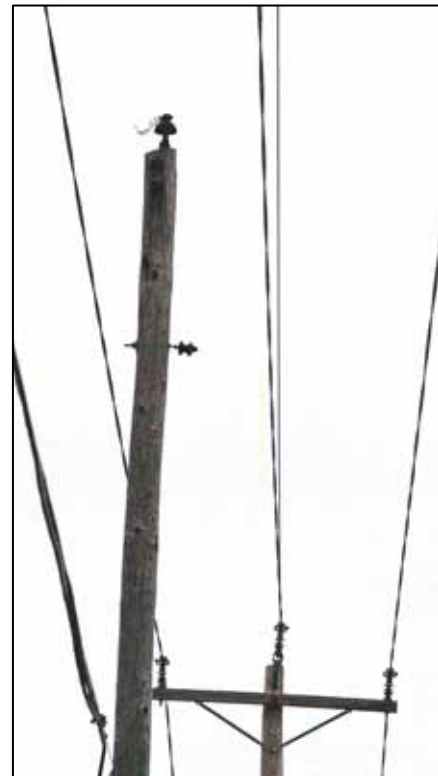
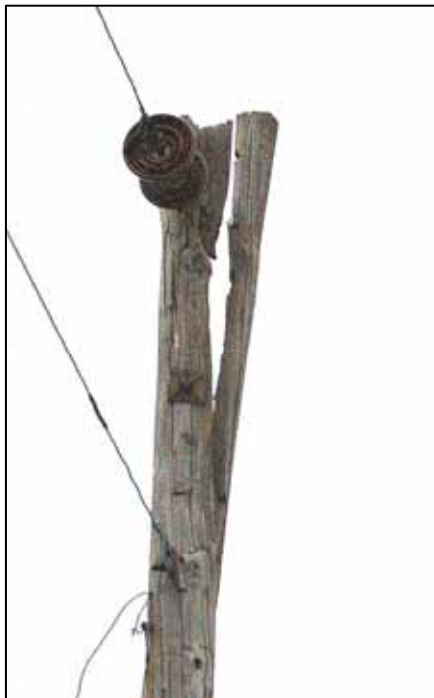
Figure 1 (Photo 05A7)
Primary too close to skip-span pole,
(NESC clearance violation)
Circuit 502, Rd. 1700N, St. Joseph

Note: AmerenIP reported that it removed the top portion (approximately 12 ft.) of this skip-span pole on June 15, 2005. This location is now in compliance with NESC clearance requirements.

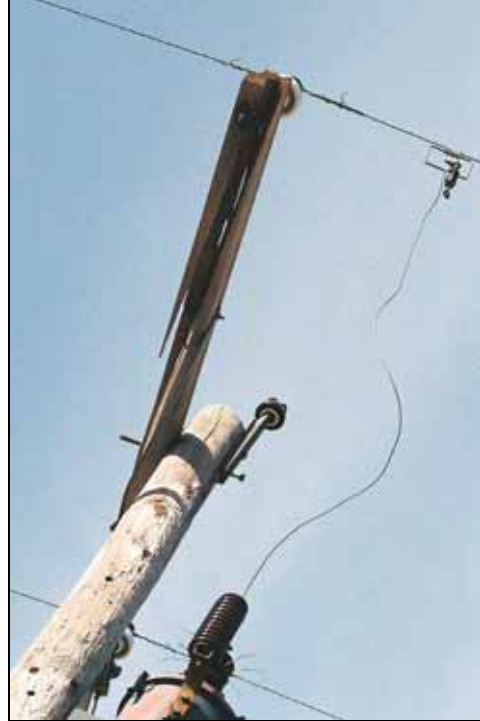
Figure 4 (Photo 05A15)
Badly split crossarm,
Circuit 502, Rd. 1900E, south of Mayview

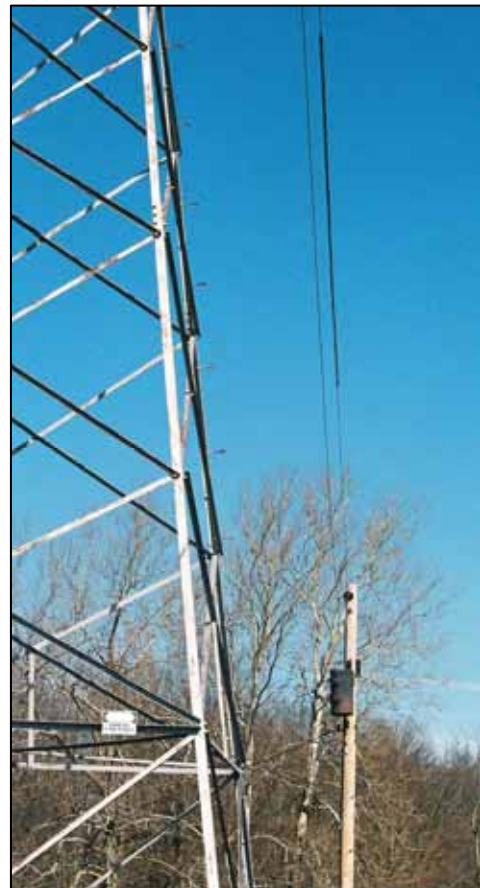
Figure 5 (Photo 05A17)
Primary too close to 69 kV lattice tower,
(NESC clearance violation)
Circuit 502, Rd. 1700N, north of Mayview

Note: AmerenIP reported that it moved the 12 kV distribution circuit farther away (7' 8") from the 69 kV transmission tower on July 18, 2005. This location is now in compliance with NESC clearance requirements.

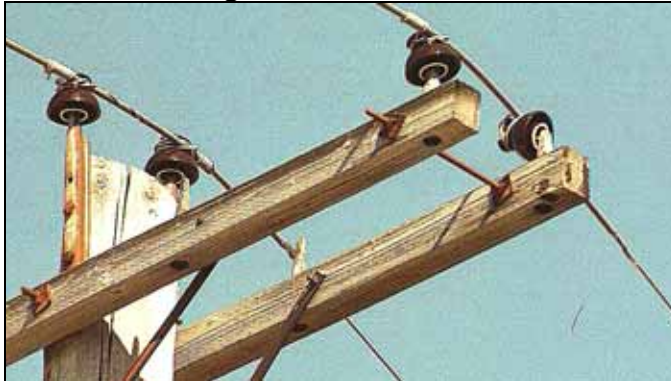
**Broken wood pin,
Circuit 205, along extension of Center St., Oneida**

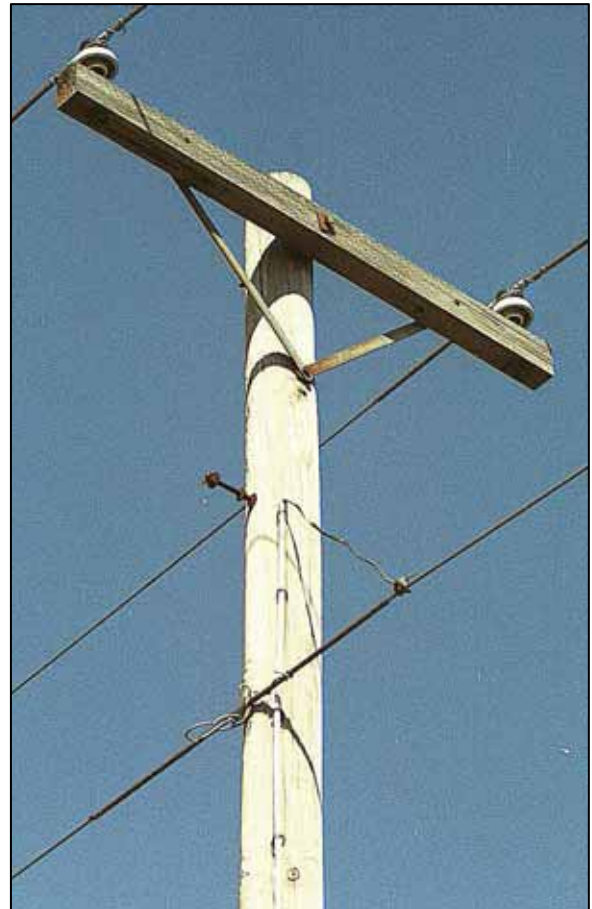
Figure 7 (Photo 05C3)

**Broken spool & neutral hanging down,
Circuit 205, Rd. 2400N, south of Oneida**

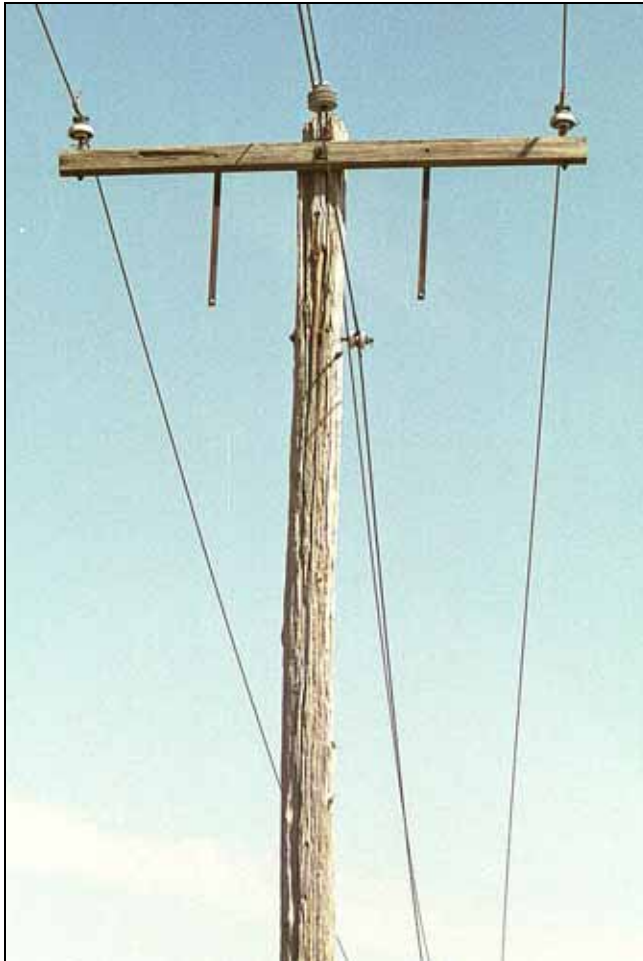
Figure 8 (Photo 05C8)
**Badly shell rotted pole and
2 hanging steel braces,
Circuit 502, CH 4, west of Altona**

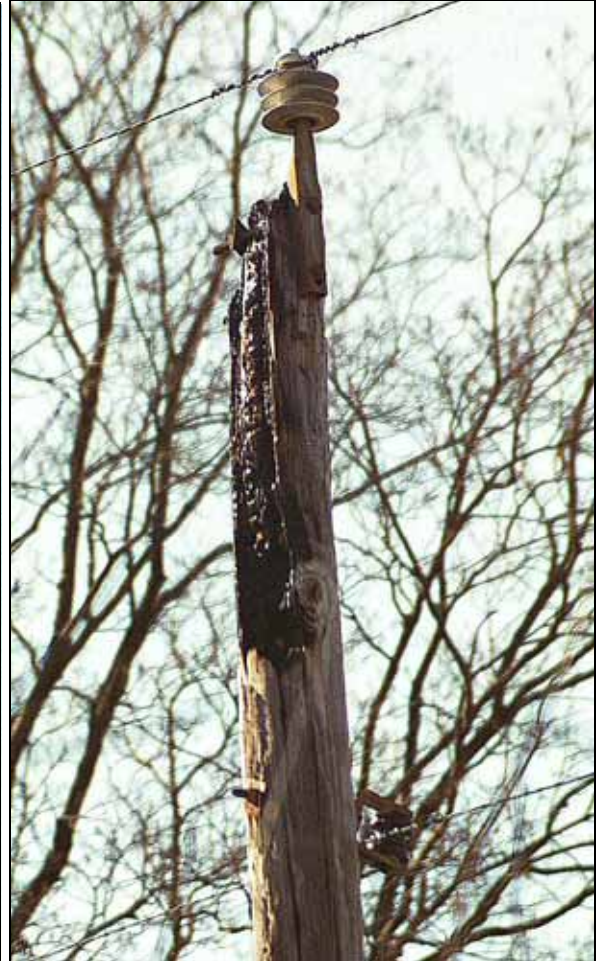
Figure 9 (Photo 05C11)
**Burned pole top,
Circuit 502, southeast of Wataga
(road not labeled on map provided)**

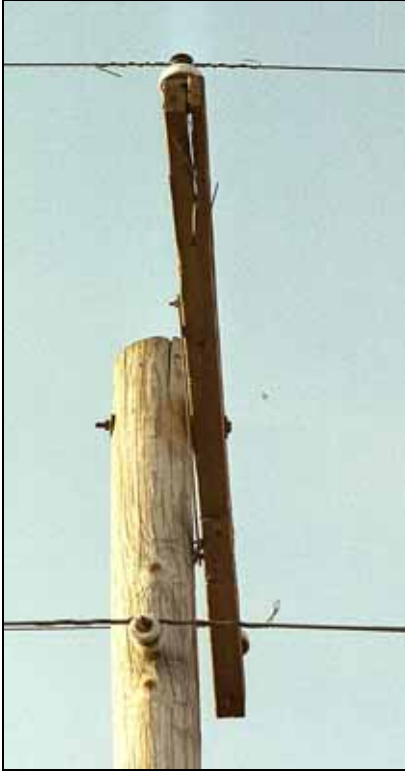
Figure 10 (Photo 05C13)
Split crossarm,
Circuit 205, Rd. 2600N, NW of Oneida

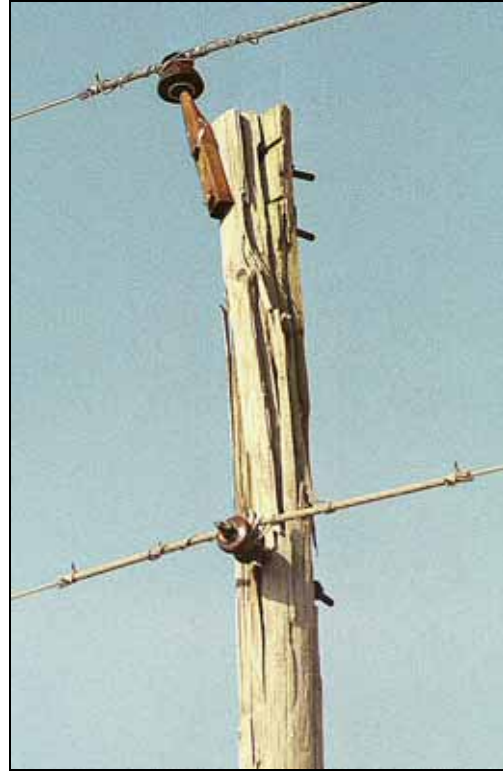
Figure 11 (Photo 05C16)
Lightning damaged pole top,
Circuit 205, Rd. 1000E, SW of Oneida

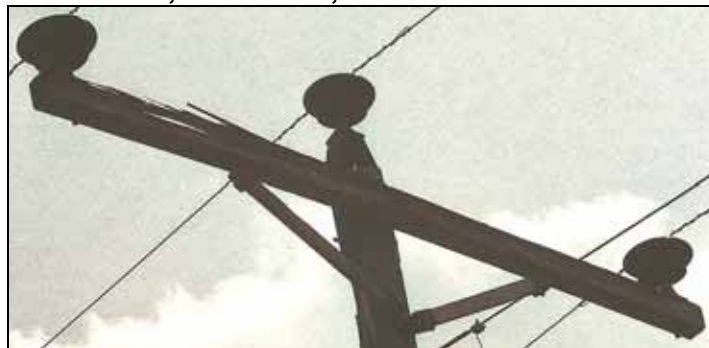
Figure 12 (Photo 05C20)
Badly lightning damaged crossarm,
Circuit 135, Road 150N, southeast of New Windsor

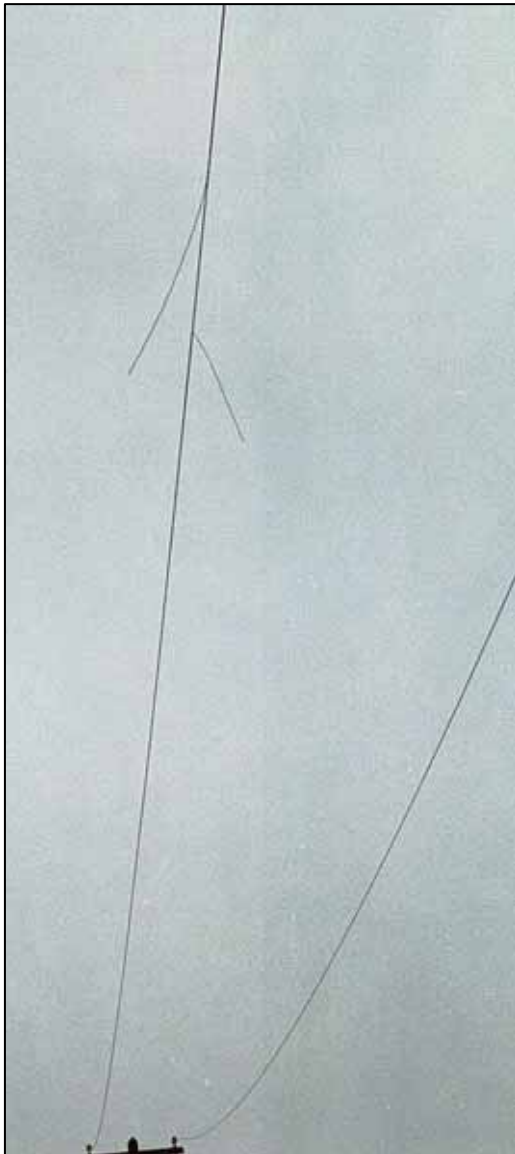
**Broken strand in 6A CW phase conductor,
Circuit 202, S. of IL Rt. 9, west of Danvers**

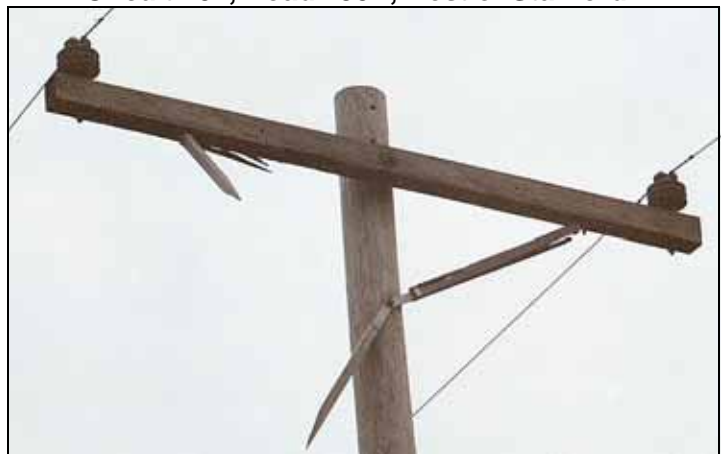
Figure 14 (Photo 05D21)

**Lightning damaged crossarm & braces
(both wood braces split/broken),
Circuit 202, Road 150E, west of Stanford**

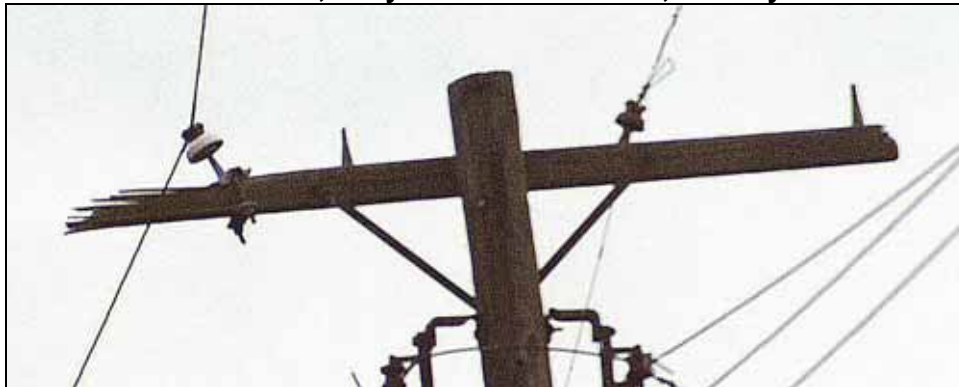
Figure 15 (Photo 05E9)
Deteriorated crossarm,
Circuit 300, Alley north of Adams St., Brooklyn

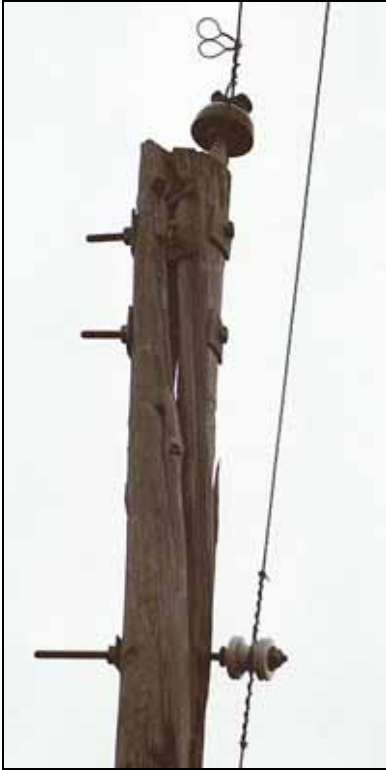
Figure 16 (Photo 05E13)
Badly split pole top,
Circuit 166, Keck Rd., east of Belleville

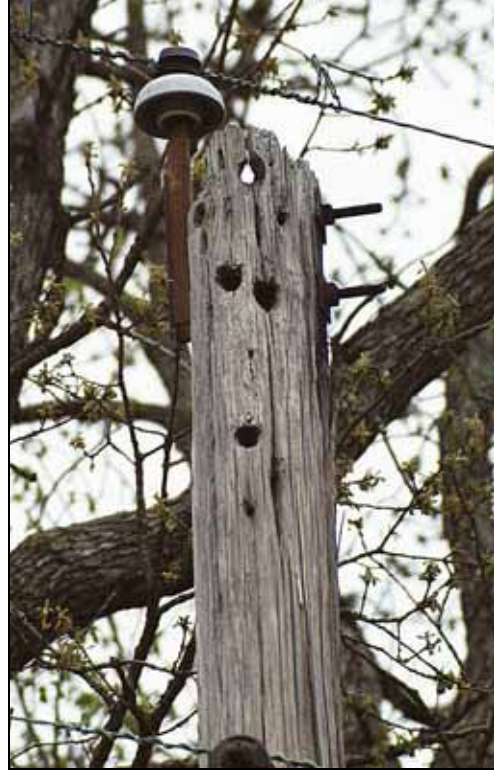
Figure 17 (Photo 05E15)
Bad pole top, with woodpecker holes,
Circuit 166, Funk School Rd., SE of Belleville

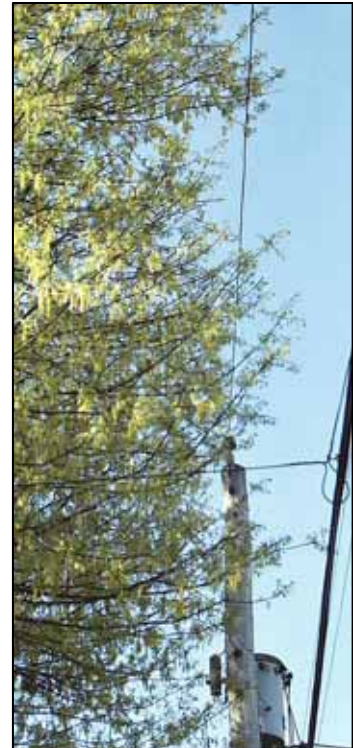
Figure 18 (Photo 05E19)
Oak tree into primary,
Circuit 235, Johnson St., New Athens

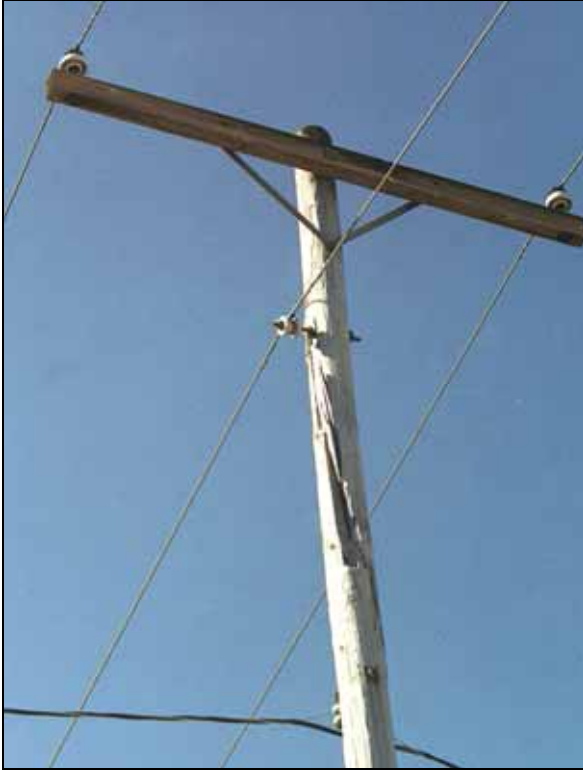
Figure 19 (Photo 05F7)

**Broken (lightning damaged) pole,
Cir. 235, White Cabin Lodge Rd., New Athens**

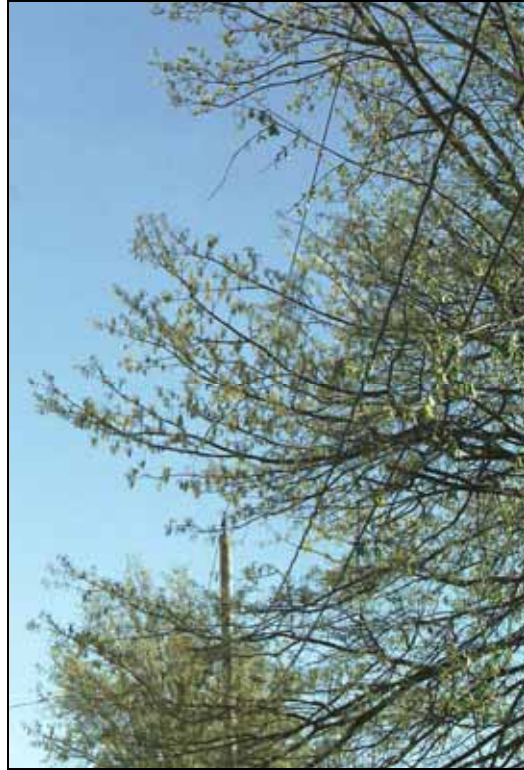
Figure 20 (Photo 05F2)

**Pin oak tree into primary,
Cir. 235, Highland St., New Athens**

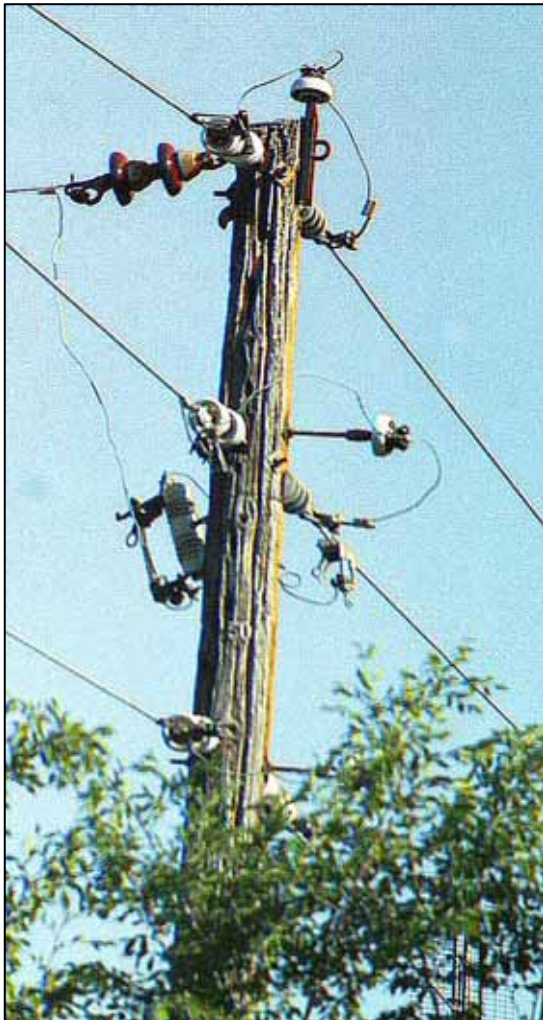
Figure 21 (Photo 05F18)
Badly shell rotted pole top,
Cir. 915, Garfield & alley N. of Lincoln, Chester

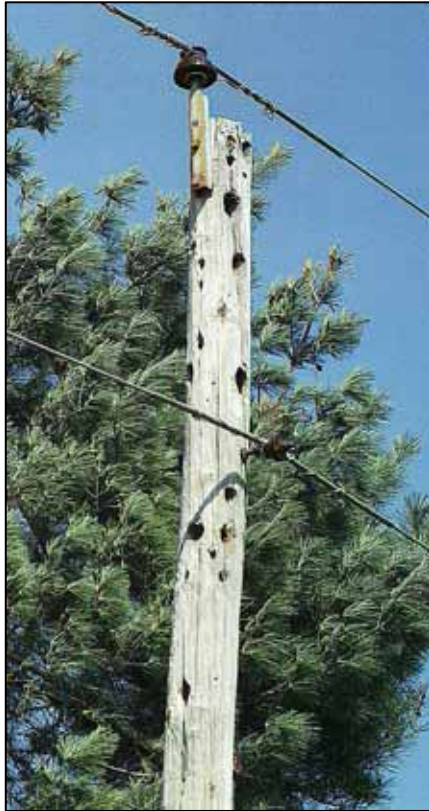
Figure 22 (Photo 05F20)
Badly shell rotted pole & split crossarm,
Circuit 915, north of Chester

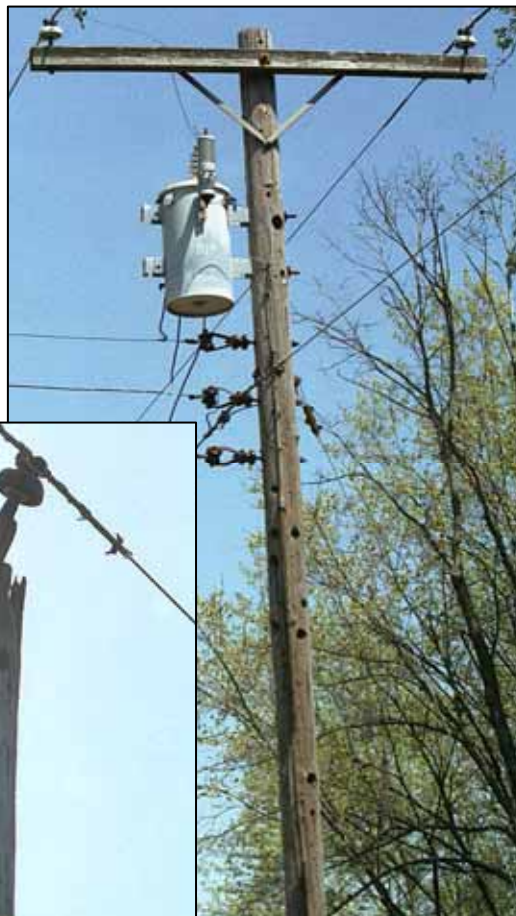
05G3) Split pole top w/ 2
holes,
Cir. 915, Union
Chester

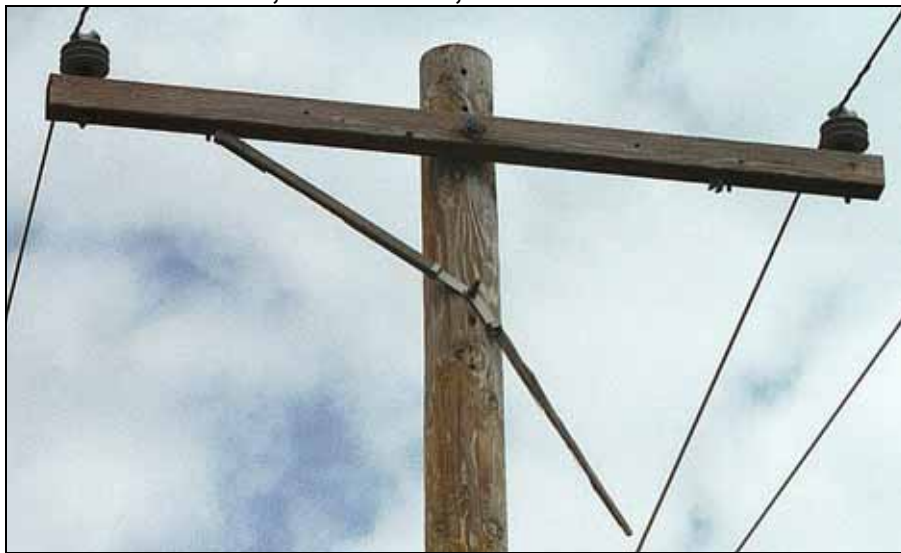
**Lightning damaged wood braces (one hanging down),
Circuit 807, Huette Road, southeast of Woodburn**

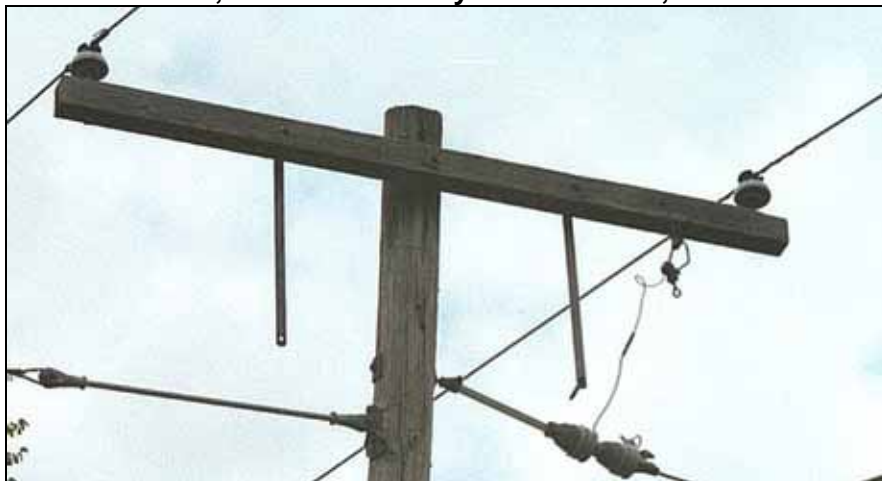
Figure 28 (Photo 05G9)

**Two steel crossarm braces hanging down,
Circuit 807, Corner of Hickory & Elm Streets, Bunker Hill**

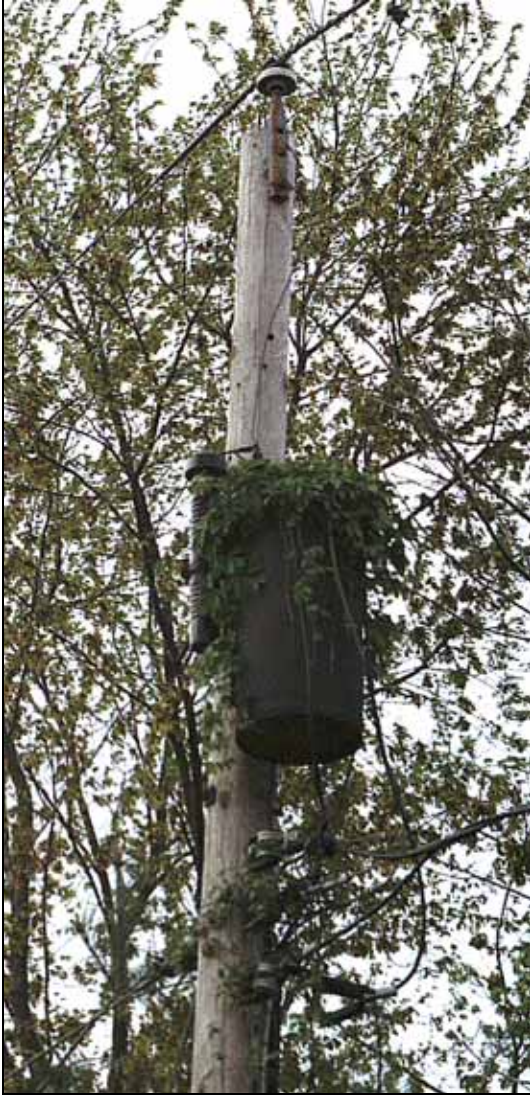
Figure 29 (Photo 05G15)
Vines on overhead transformer,
Cir. 807, Ness School Rd., SE of Bunker Hill

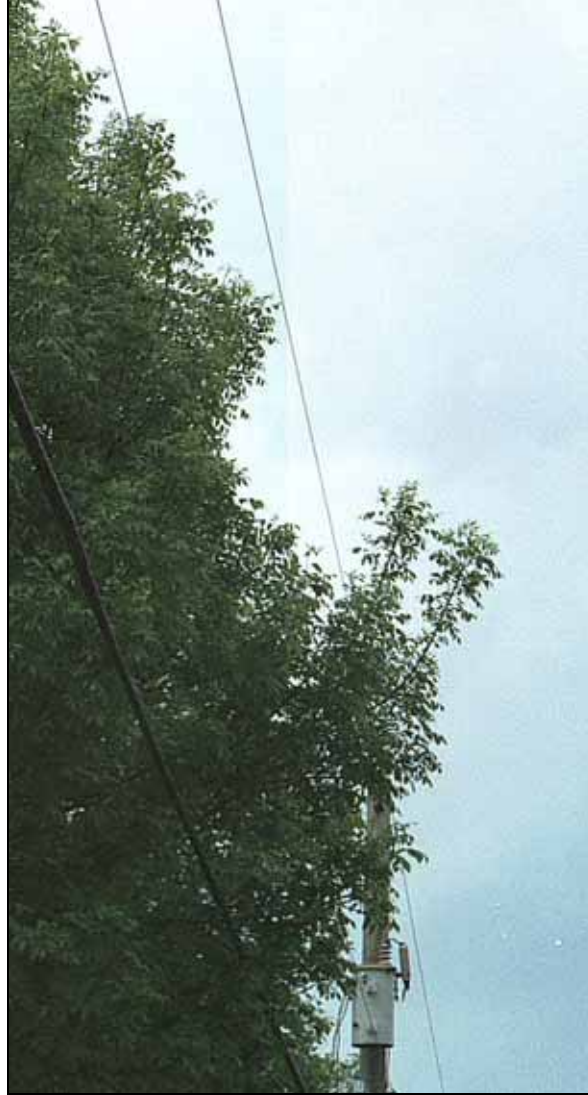
Figure 30 (Photo 05G16)
Ash tree growing into primary,
Circuit 807, East St., Bunker Hill

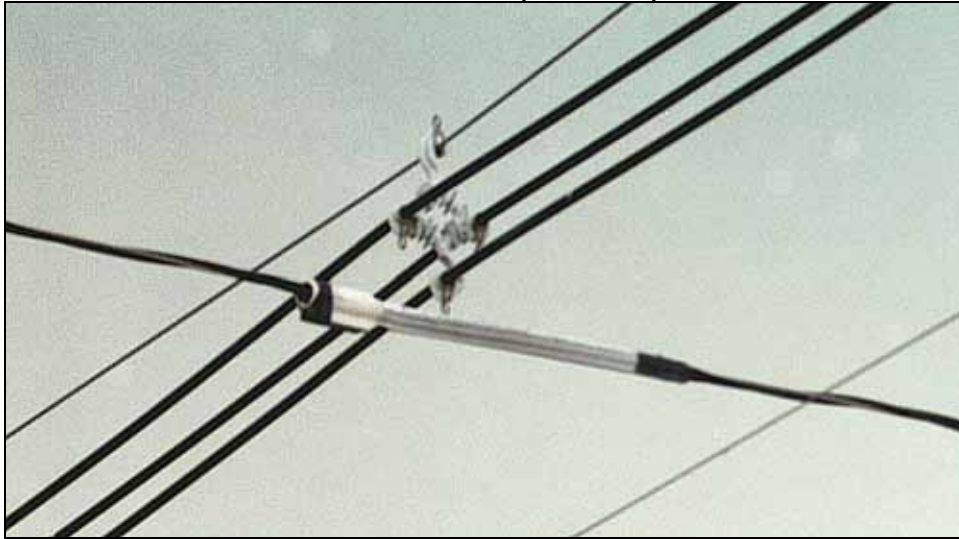
On the way back from its inspection of Hillsboro Circuit 807 on April 20, 2005, Staff noticed an NESC violation in Benld involving inadequate vertical clearance of AmerenIP's 12 kV Hillsboro Circuit 803 over a street light secondary circuit. This inadequate clearance situation, at the corner of Central Avenue (IL Rt. 138) and E. Oak Street, Benld, is shown in Figure 31. The NESC requires a minimum clearance of two feet for this situation, instead of the 6" to 12" clearance existing at that time. Note that AmerenIP had placed line hose on the secondary at the crossing point under the 12 kV spacer cable circuit some time earlier, indicating that they were aware then of the clearance problem, but had not resolved it properly. Staff sent AmerenIP an email message describing this code clearance violation on June 13, 2005. AmerenIP reported on August 2, 2005, that it removed this span of street light circuit on July 19, 2005, feeding the street light from a different direction and resolving this NESC violation.

**Inadequate clearance of 12 kV primary over a street light secondary (NESC violation),
Circuit 803, Corner of Central Ave. (IL Rt. 138) & E. Oak St., Benld**

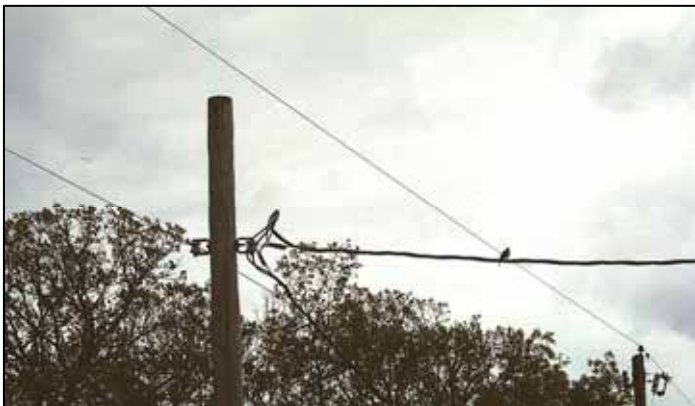
**Primary approx. 1 ft. above skip-span pole (NESC violation),
Circuit 212, Road 650N, ESE of Georgetown**

Note: AmerenIP reported that it cut the top off the skip-span pole on July 1, 2005, resulting in a 6 ft. clearance from the primary to the remaining secondary and neutral. This location is now in compliance with the clearance requirements of the NESC.

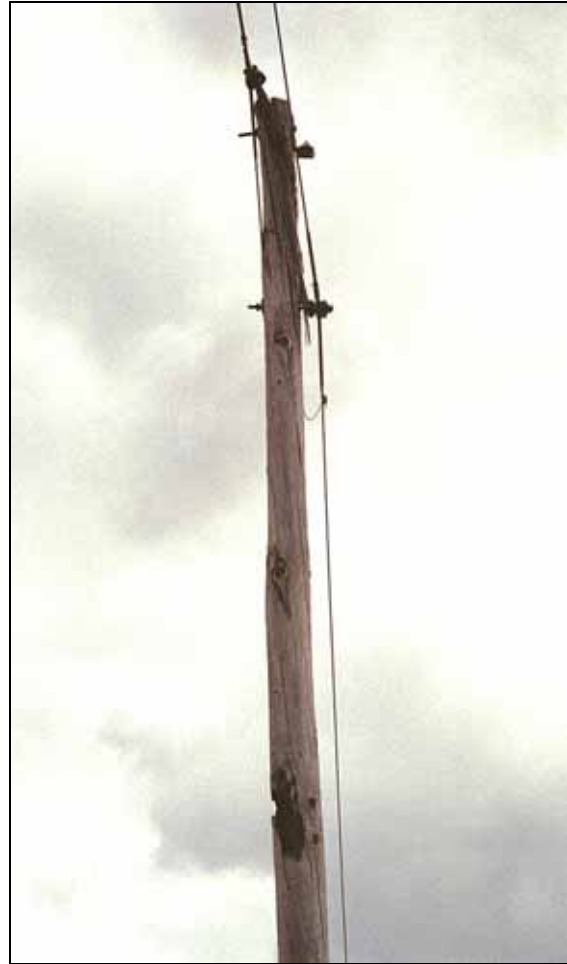
Figure 34 (Photo 05H9)

**Burned pole & lightning damaged pole top,
Cir. 212, Rd. 2000E, SE of Olivet**

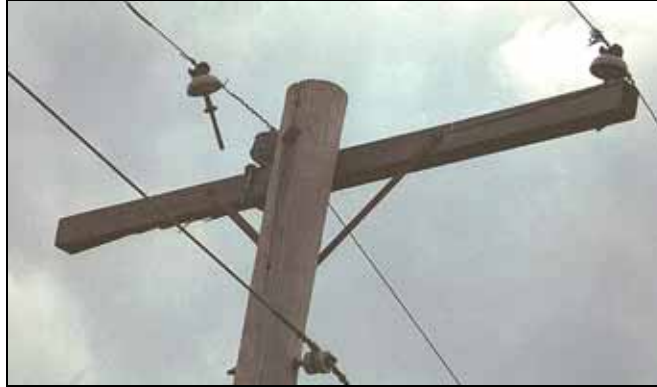
Figure 36 (Photo 05H7)
Badly split crossarm (saddle pinned),
Circuit 212, County Highway 26, east of Vermilion Grove

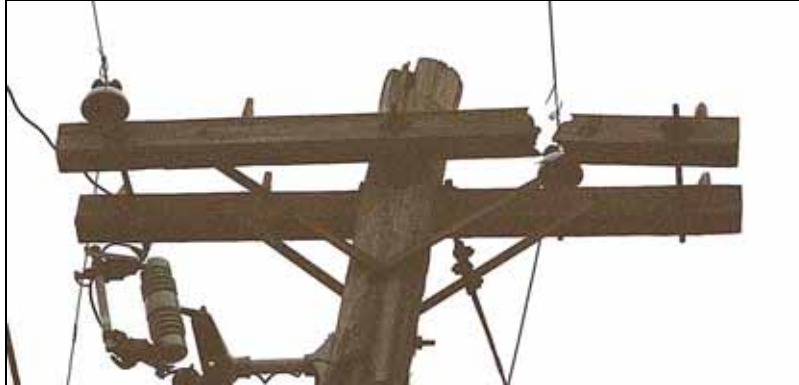
Figure 37 (Photo 05H11)
Broken crossarm (2nd arm may not be needed),
Circuit 212, west of Cedar St. in the alley north of Indiana Ave., Olivet

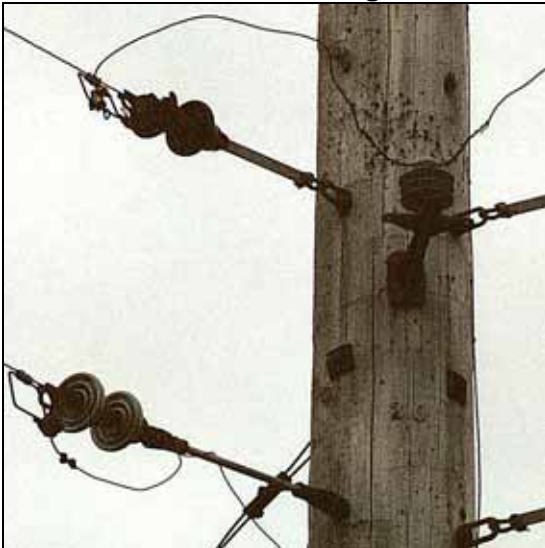
Figure 38 (Photo 05H12)
Broken 12 kV suspension insulator,
Cir. 212, Rd. 1500E & College St., Olivet

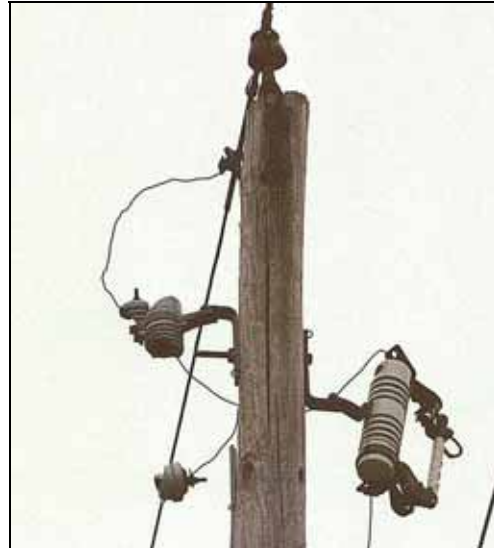
Figure 39 (Photo 05H13)
Broken lightning arrester,
Cir. 212, N. of Main St., Vermilion Grove

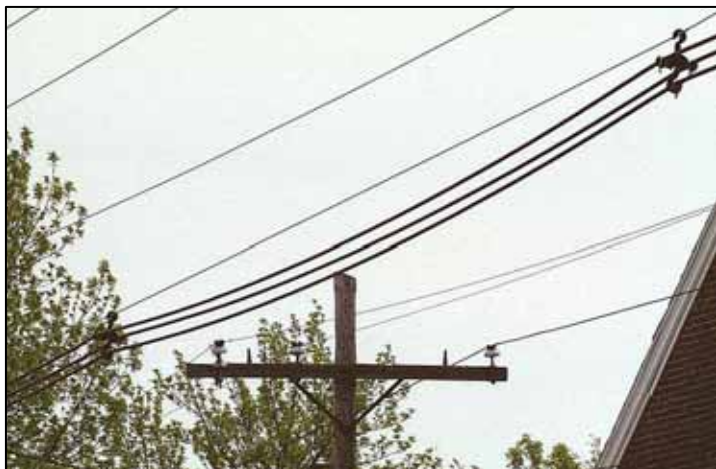
Figure 40 (Photo 05H21)
12 kV primary approx. 6" above 4 kV primary
on a skip-span pole (NESC clearance violation)
and a deteriorated 4 kV crossarm,
Circuit 121, Gilbert & English Sts., Danville

Note: AmerenIP reported that it installed a taller pole with new crossarms supporting both the 12 kV and 4 kV circuits at this location on September 30, 2005. This location is now in compliance with the clearance requirements of the NESC.

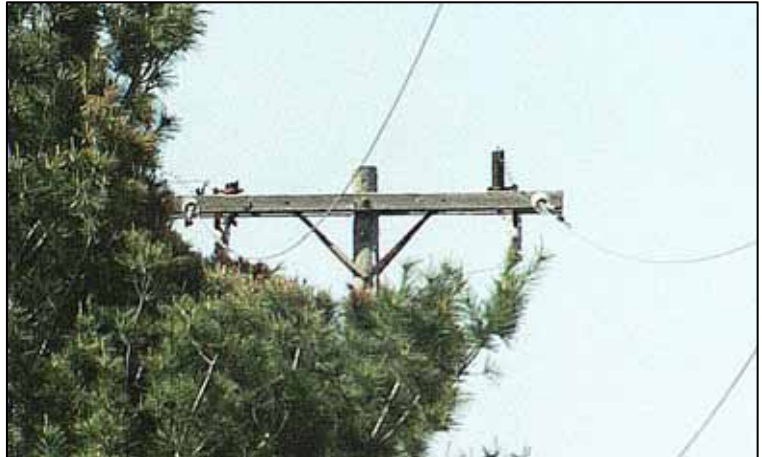
Figure 41 (Photo 05J10)
Primary burning tops of pine trees,
Cir. 331, N. of Strawn Crossing Rd.,
northeast of Jacksonville

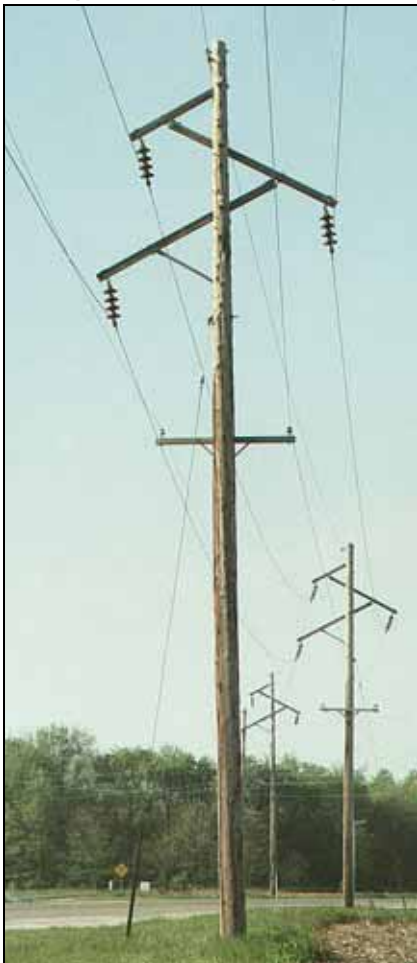
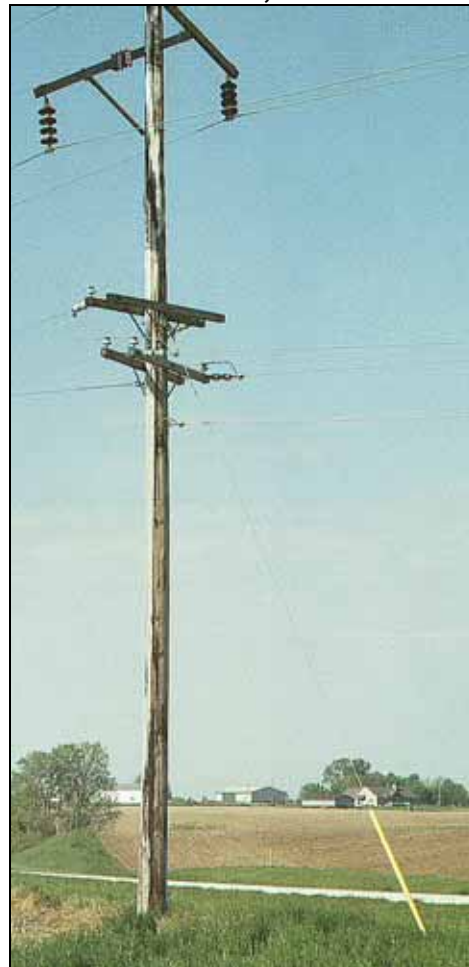
Figure 42 (Photo 05J16) **Figure 43 (Photo 05J17)**
69 kV (Fig. 42) & 12 kV (Fig. 43) downguys passing between 12 kV phase conductors without
required strain insulators in the downguys (**NESC violations**),
Circuit 331 (69 kV Strs. 16 & 18), Rt. 78 south of Valevue Acres Drive, north of Jacksonville

Note: AmerenIP reported that it installed strain insulators in these downguys (shown in Figures 42 & 43) as required by the code, as well as at 69 kV Structure 17 (the other

similar violation), on July 5, 2005. All three locations are now in compliance with the requirements of the NESC.

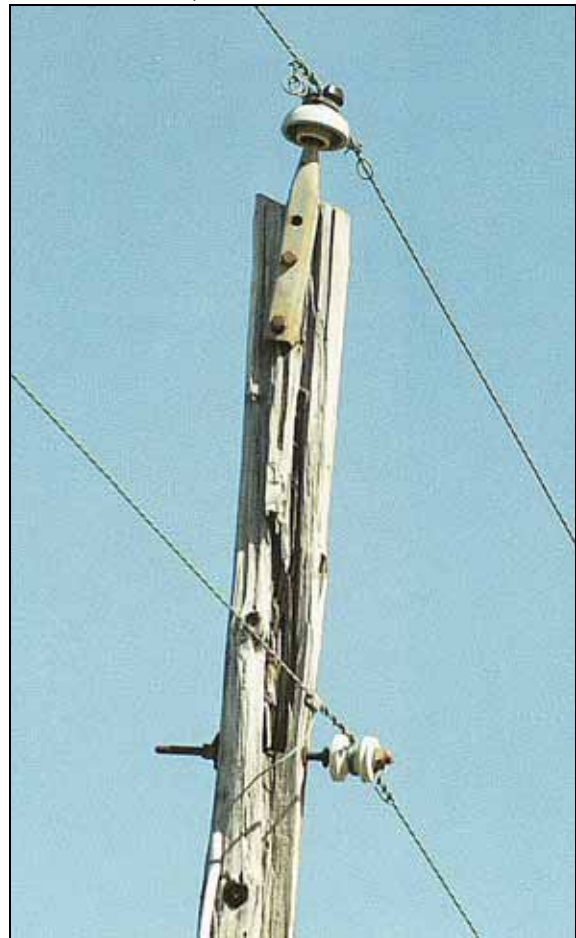
Figure 45 (Photo 05J19)
Lightning damaged pole top,
Circuit 331,
IL Rt. 78, north of Jacksonville

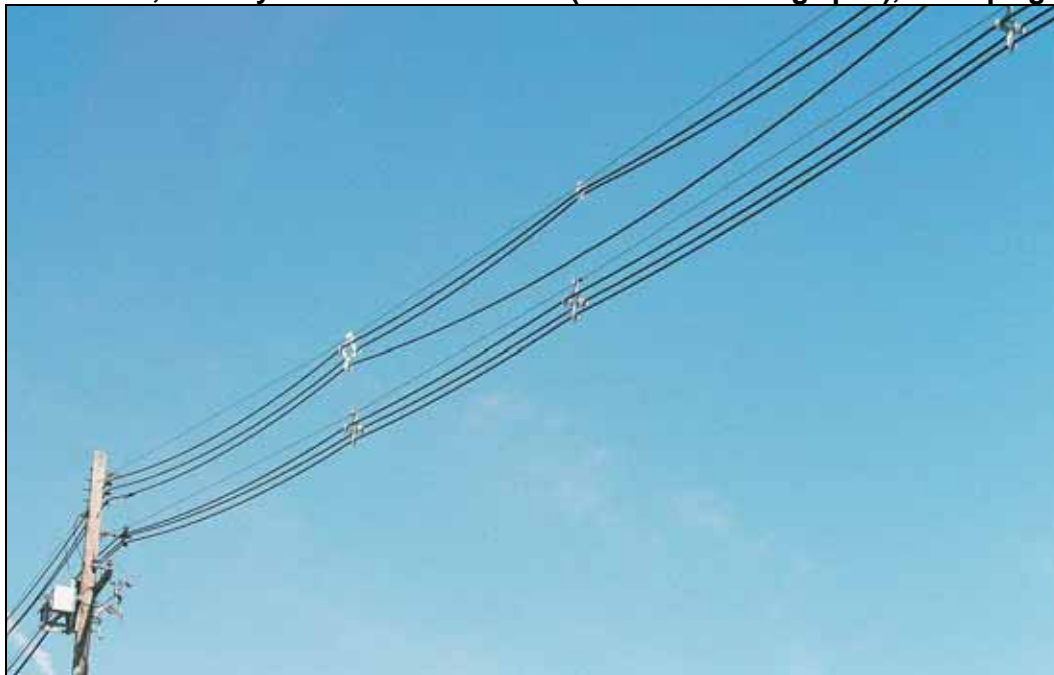
Low-hanging 12 kV spacer cable conductor due to broken spacer, Circuit 222, Hickory St. south of North St. (railroad crossing span), Champaign

Staff has found many broken spacers on AmerenIP spacer cable circuits in recent years, and the problem seems to be particularly bad in the Champaign/Urbana service area (perhaps because AmerenIP has more spacer cable there than in most areas). Each broken spacer causes additional loading on adjacent spacers, sometimes resulting in a propagation of spacer failures along the span. Anytime one or more spacers fail, the design clearances and strengths of the line (as well as aesthetics) are compromised. As already discussed, violations of the National Electrical Safety Code sometimes result. Staff is aware that primary spacer cable has not been a standard for new construction at AmerenIP for several years and that the spacers in existing spacer cable circuits, unless recently replaced, are becoming old. Based on the increasing number of failures observed, many of the aged spacers are apparently in poor condition. Staff urges AmerenIP to investigate this escalating problem and to implement an appropriate action plan to address it.

- Fifth, AmerenIP should investigate its apparently escalating problem with broken spacers on its spacer cable circuits and implement an appropriate action plan to address it.

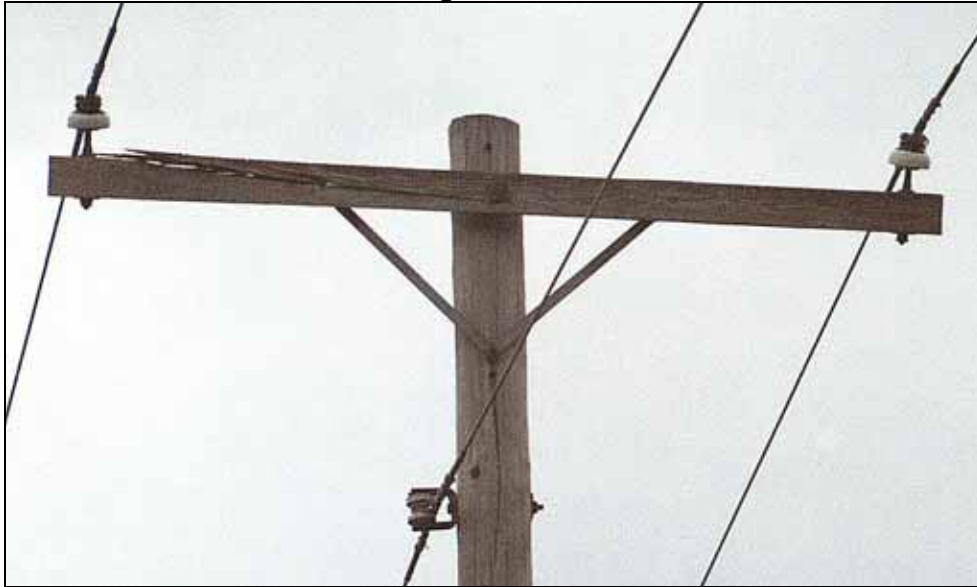
Figure 47 (Photo 05E5)
Badly split single crossarm (NESC structural strength violation),
Circuit 192 crossing of I-72 at Exit 128, Niantic

Note: AmerenIP reported that it replaced the single crossarms on both sides of this interstate crossing with new double crossarms on April 15, 2005. This location is now in compliance with the requirements of the NESC.

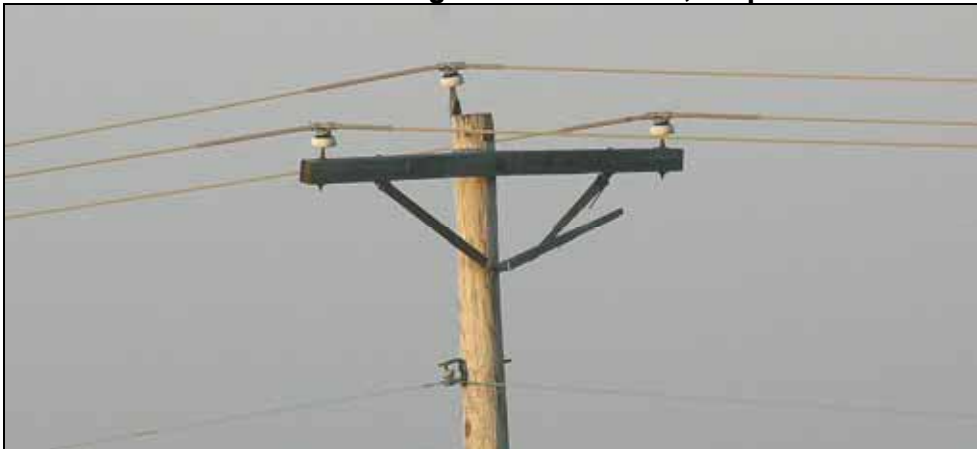
Figure 48 (Photo 05-IP663)
Badly split wood brace on single crossarm (NESC structural strength violation),
Circuit 190 crossing of I-72 at Exit 122, Illiopolis

Note: AmerenIP reported that it replaced the broken wood brace on September 15, 2005, and replaced the single crossarms on both sides of this interstate crossing with new double crossarms on September 21, 2005 (south side) and September 22, 2005 (north side). This location is now in compliance with the requirements of the NESC.
